Determination of air permeability and water tightness and resistance to wind load

Manufacturer: KINGAS
Type: Balcony door with aluminium cladding
Size: 885 x 2085 mm
Condition at arrival: No visible damage
Date of arrival: 2008-10-14
Date of testing: 2008-10-20
SP's serial number: 999

Manufacturer: KINGAS
 Type: Balcony door wood
 Size: 885 x 2085 mm
 Condition at arrival: No visible damage
 Date of arrival: 2008-10-14
 Date of testing: 2008-10-21
 SP's serial number: 998

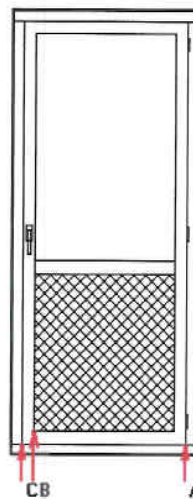
Water tightness according to SS-EN 1027 metod A up to 600 Pa (see attached pictures)

Point A: Leakage between frame and sash
Leakage degree 1 after one minute at 150 Pa
Leakage degree 0 200 Pa

Point B: Leakage infill joint corner
Leakage degree 2 after two minutes at 300 Pa
Leakage degree 3 after two minutes at 600 Pa

Point C: Leakage between frame and sash
Leakage degree 1 after one minute at 450 Pa

Leakage grading
0 No leakage
1 One or a few drops
2 Several drops
3 Minor run
4 Minor flow
5 Considerable flow

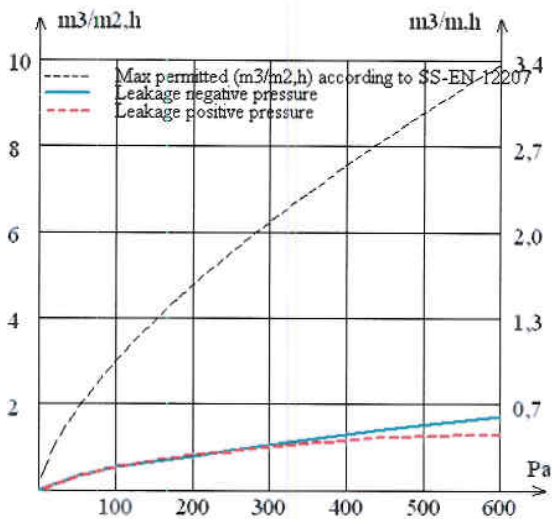
Testing according to SS-EN 1026 up to 600 Pa

Air permeability

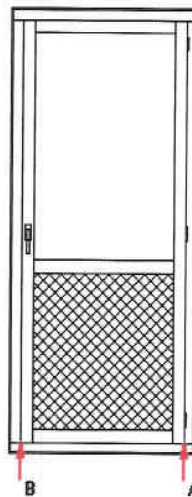
Water tightness according to SS-EN 1027 metod A up to 600 Pa (see attached pictures)

Point A: Leakage between frame and sash
 Leakage degree 2 immediately at 100 Pa
 Leakage degree 3 immediately at 300 Pa
 Leakage degree 4 immediately at 600 Pa

Point B: Leakage between frame and sash
 Leakage degree 2 after one minute at 100 Pa
 Leakage degree 3 immediately at 200 Pa
 Leakage degree 4 immediately at 600 Pa

0 No leakage	3 Minor run
1 One or a few drops	4 Minor flow
2 Several drops	5 Considerable flow

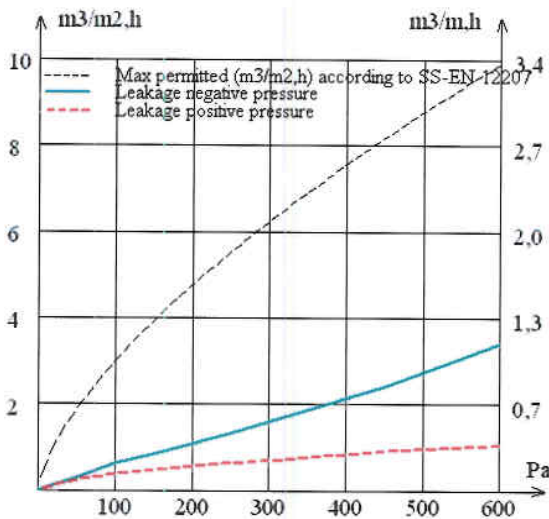
Testing according to SS-EN 1026 up to 600 Pa

Air permeability
